Freeze Thaw Resistance of Pervious Concrete

NRMCATM
NATIONAL READY MIXED
CONCRETE ASSOCIATION

Projects in Freeze Thaw Conditions

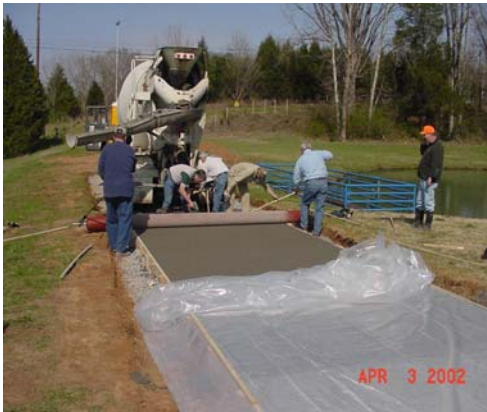
The project involves a walking path and a parking area. The walking path has 5" of pervious concrete over a 5" stone base, on top of underlying clay soil. The parking area has 6" of pervious concrete over a 5" stone base; it includes some drainpipes. There are about 1200-1300 cubic yards in the parking area, while the walking path is 1/3 mile long. The location undergoes an average of about 90 cycles/year. However, the climate is not a hard freeze, as the average daily temperature does not drop below freezing point very often. There is precipitation during winter so the location is considered as a wet freeze. There was some vacuum sweeping after a heavy rainstorm deposited mud on the pathway. The current performance is good and there is no clogging or raveling.

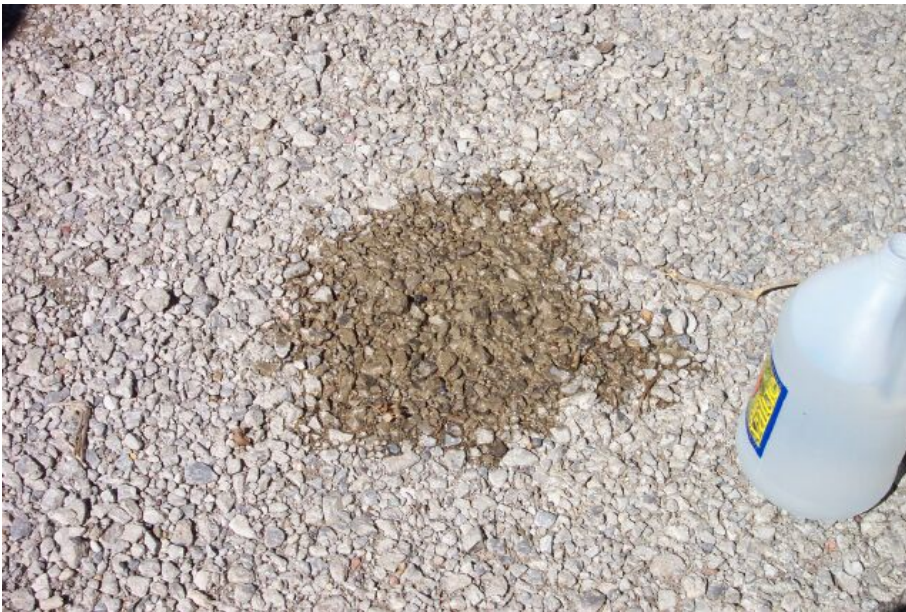
The pervious concrete was placed as a driveway surface to keep a rustic look. The driveway is about 400 feet long and 10’ wide. The traffic is pickups, SUVs, and cars (all four-wheelers), which have traveled up and down the hill every day for 11 years. The material was placed 4’ to 6” thick and leveled with a regular garden rake. It was compacted with a walk-behind flat plate compactor. There are no drainpipes or curbs and gutters. The location undergoes an average of about 212 cycles/year. The average daily temperature stays below freezing for 62 consecutive days (on average) but there is very little precipitation during this period and only about 10 inches of rain throughout the year. So the climate is considered a hard dry freeze with very high freeze thaw cycling. There is no annual maintenance on this project and, after 11 years, the performance has been good. There is loose rock on the edge and some clogging where rain has caused soil to run onto the pervious. We placed a yellow color in the pervious when installed but it is not there now. The owner has a science background and is pleased with the results. The neighbors have placed base gravel twice and it continues to go down into the mud. The material was cheaper than concrete but more expensive than gravel base. Mixture design was cement = 300 lbs / cu.yd; coarse aggregate # 57 – 1” minus size 2570 lbs / cu.yd; water about 20 gals / cu.yd. Plastic unit was about 106 pcf, no entrained air or water reducer or fly ash. % void based on ASTM C-138 20 to 24 % . When filling a 4”x8” cylinder with pervious and then adding water 2” of water, can be placed into the cylinder. And it will fill the voids. Compressive strength after 28 days about 1000 psi. No special curing of the pervious. Just placed and opened for traffic.

The pervious fell apart on an incline of 10% where it was about 2" thick and cars and trucks would spin going up the hill.

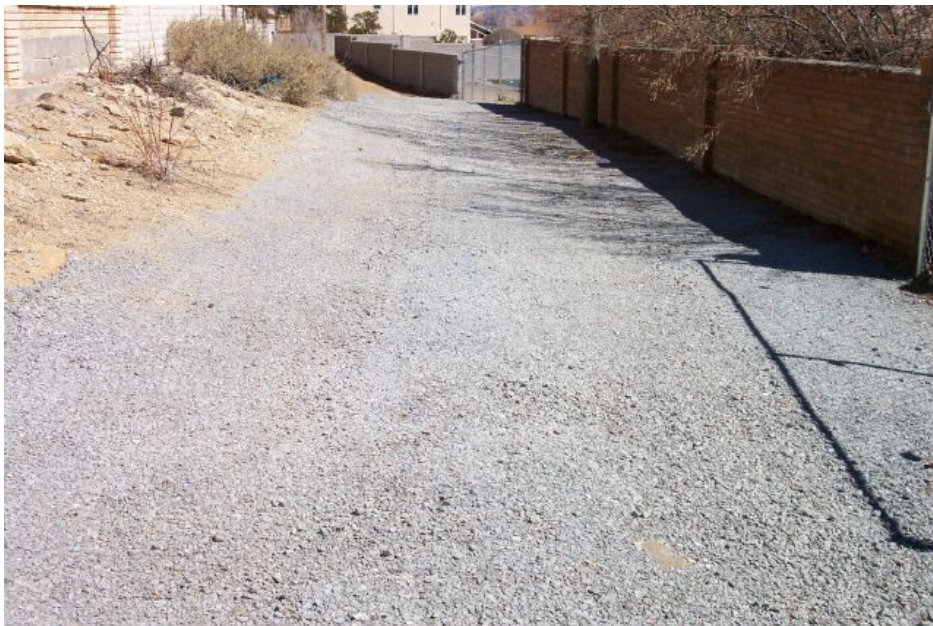
The pervious concrete is about 400 sq. yards. The traffic is a garage truck pickup, an SUV and a dog (all four-wheelers). The material was placed 4" to 6" thick and leveled with a regular garden rake. It was compacted with a walk-behind flat plate compactor. No drainpipes or curbs and gutters. The location undergoes an average of about 212 cycles/year. The average daily temperature stays below freezing for 62 consecutive days (on average) but there is very little precipitation during this period and only about 10 inches of rain throughout the year. So the climate is considered a hard dry freeze with very high freeze thaw cycling. There is no annual maintenance on this project and, after 10 years, the performance has been good. There is more ground cover to keep the mud down and vehicles park but do not fall into the mud. Part of the pavement is on a hill and it slid some. There is one crack that we have noted. The pervious lot has been through many snows and it has not turned in to a pile of loose rock. Mixture design was cement = 300 lbs / cu.yd; coarse aggregate # 57 – 1" minus size 2570 lbs / cu.yd; water about 20 gals / cu.yd; plastic unit we about 106 pcf. No entrained air or water reducer or fly ash. % void based on ASTM C-138 20 to 24 % . When filling a 4"x8" cylinder with pervious and then adding water, 2" of water can be placed into the cylinder. And it will fill the voids. Compressive strength after 28 days about 1000 psi. No special curing of the pervious. Just placed and opened for traffic.
